HTA AVIATION PROVIDES TROUBLE-SHOOTING AND RECOVERY OF AN ASTRA SPX WITH A STARTER/GENERATOR PROBLEM.

FORT WORTH, TX. June 28, 2008 – HTA Aviation, LP, a privately held woman owned small business entity provides trouble-shooting and recovery of an Astra SPX with a starter/generator problem and discovers an uncompleted Service Bulletin 100-54-252 as the root cause for the conditions.

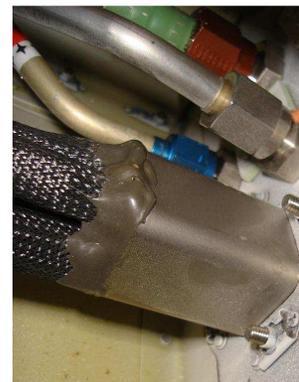
The complete system and related components were inspected. A short was present with the starter/generator cables. The left pylon lower panels were removed and the area inspected. A short was discovered at the pylon feed through cable support as shown in the photo to the left.

Upon this discovery, the right pylon area was inspected with no short visible as shown in the photo to the right. After reviewing all of the findings, it was evident that some of the steps required in Part B/C of the SB had not been accomplished. The new cable supports were installed; however, the new protective sleeve P/N 6653957 “EXPENDO” black material did not pass through the new cable support as required by the SB. In addition, the installation had not been injected with DAPCOCAST 18-4 sealant between starter generator cables and the cable support. A correct accomplishment is shown in the photo below:

The damaged left cable support was replaced and new cables having protective sleeve installed were passed through the cable support. DAPCOCAST 18-4 sealant was injected between starter generator cables and the cable support. After operational checks were performed and passed, the aircraft was returned to service.
